NEW ZEALAND HELICOPTER

SAFETY UPDATE

SEPTEMBER 2019

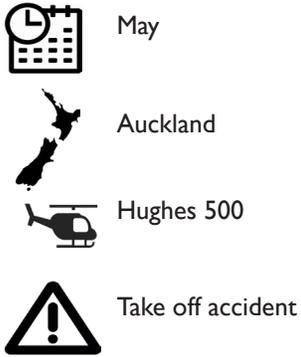
The pilot forgot to uncouple the foot pedals before the take off. Once the helicopter became airborne it immediately began to spin. The pilot dropped the collective and a skid partially collapsed on contact with the ground.

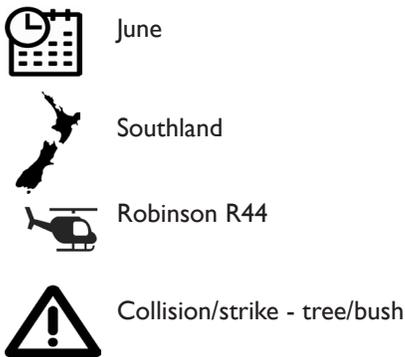
During a mustering operation the helicopters main rotor blades contacted foliage. This was not noticed until the post flight inspection. The investigation determined that the pilot may have been task fixated on the cattle and as such lost situational awareness while operating at foliage height.

The pilot has been counselled on his actions, has undergone low level operational training and conducted a FCCC 137 check.

The operator is also implementing SOPs for mustering.

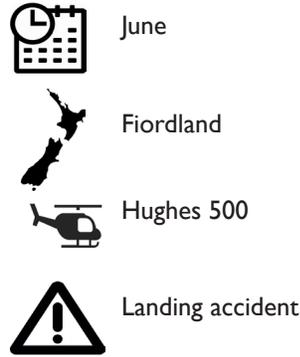
While carrying out a WARO operation, the pilot landed on a ridge top, reduced power to ground idle and secured the friction. On exiting the helicopter the pilot checked the skids which appeared flat and solid against the surface and the helicopter appeared level. As the pilot walked away he saw the helicopter fall backwards. The tail rotor contacted the ground and was damaged. The report determined the the vibration of the helicopter allowed the hard-frozen surface to give way to a soft area under the LH rearer heel of the helicopter.

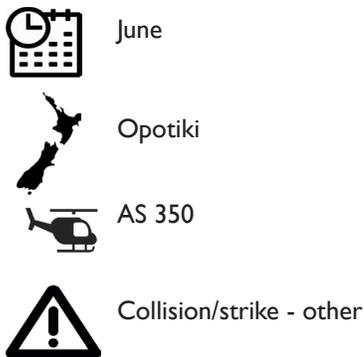
On landing, while positioning the helicopter to find level ground, the main rotor blade made contact with the roof iron on the edge of a hut in the landing area. The aircraft was shutdown and an engineering inspection found that the blades were not damaged.

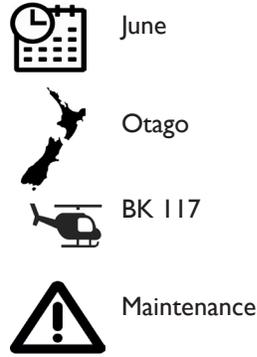
After engine repair and ground test a bolt was found on the engine deck and another on the grass. On further investigation it was noted that all Inlet Housing bolts were loose and the 2 bolts found had come out altogether. Corrective Action Taken - New Lock Washers PN MS35333-74 and tooling was sent to the operator to re-torque the bolts, and suggested a vibe run be carried out prior release to service. This has now been carried out successfully and the aircraft is released to service.
