NEW ZEALAND HELICOPTER

SAFETY UPDATE

MARCH 2018

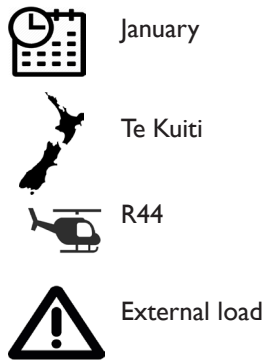
The helicopter was engaged on an operation laying out fenceline posts when they noticed the load line slip and witnessed the centre post spill out. The pilot lowered collective and pulled speed back in an attempt to put the load on the ground and secure it, however the remaining posts began to fall away. The pilot elected to jettison the load. When he did he felt a sudden bang and realized that tail rotor authority had been lost when the empty strop flicked up and wrapped around the tail rotor pitch links. The pilot attempted a run on landing but lost control and collided with terrain. The pilot was not injured but the helicopter was destroyed.

Following the accident the operator created a requirement for pilots conducting external load operations to be briefed by a pilot that had attended a load rigging course. Further controls were implemented in company lifting procedures including strop selection, rigging, and personal protective equipment use. Refresher training on external load rigging and lifting was carried out.

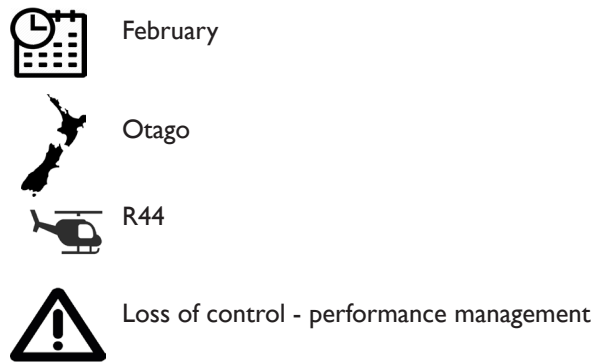
The helicopter was engaged on a spraying operation on a 30ha L-shaped block. A climb was required to reach the top of the block so the pilot down loaded the helicopter to ensure sufficient performance would be available to reach the top.

The up-and-down portion of the block was nearly completed when the pilot went to finish an area of the northern boundary. This involved a right hand descending turn into an uphill run. The pilot estimated there was close to 200 litres on board and he was at about 2000 feet.

Coming out of the turn a rate of sink developed which the pilot sought to counter by reducing collective resulting in a loss of RPM. The load was jettisoned immediately and an attempt made to fly forward out of trouble, however it was clear that there was insufficient height and power to recover. The pilot picked a spot ahead and attempted to run on, the helicopter ran 10-20 metres up the hill but rolled off a bank before coming to a complete stop. It rolled several times and stopped against a tree. The pilot was uninjured. The operator's investigation report identified complacency as the principle cause of the accident, as the pilot didn't properly consider the effect of the prevailing temperature and altitude on the aircraft's performance. The report noted also that the pilot was thinking about returning home at the time and was flying 'as if the job was already done'. The main lesson learned was that operators should be diligent to ensure that complacency does not creep up.

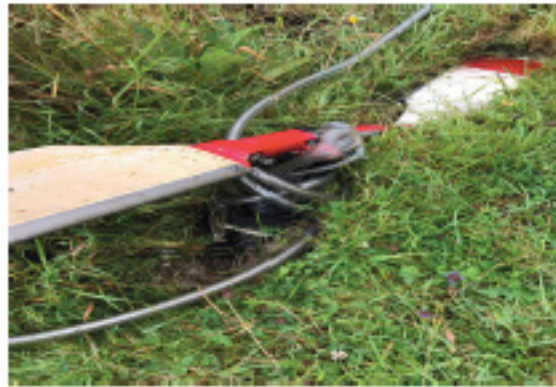
The Hughes 500 was conducting external load operations moving beehives in the Raetihi area. For this operation, two company helicopters had been engaged, with both pilot’s electing to use a bee-wing, attached to the belly hook of the aircraft with a short 10 metre cable, to lift the pallets of beehives.

At approximately 0920 hours NZDT, the aircraft was on a return flight from the drop off location when the cable,

weighted only with the bee-wing, came into contact with the tail rotor. This resulted in the cable wrapping around the tail rotor hub and gearbox, causing the tail rotor assembly and cable with the bee-wing attached, to depart from the aircraft. As a result, the aircraft yawed to the right and the pilot was unable to maintain directional control. After several rotations, the aircraft struck the side of a ridge, rolled approximately 35 metres down the slope and came to rest on its right side. The pilot, the sole occupant of the helicopter, sustained significant injuries and was subsequently airlifted to hospital. The safety investigation was unable to determine conclusively why the cable contacted the tail rotor. It is most likely that the short stop, low mass configuration increased the risk of contact with the tail, particularly when combined with an airspeed at which the load may have become unstable.

Image of the tail rotor and entangled line.

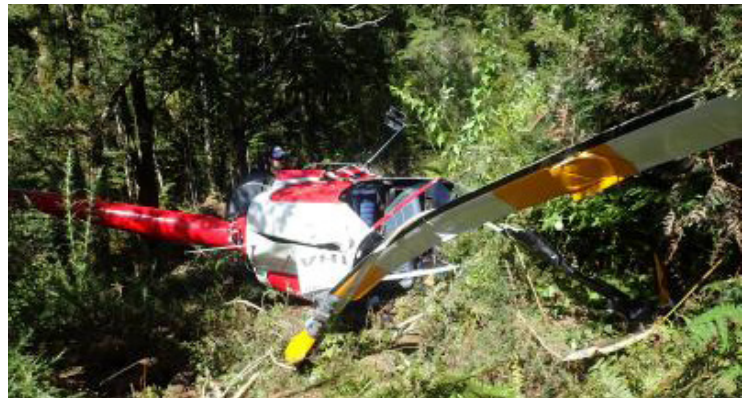
The Rescue Coordination Centre received a distress beacon from the aircraft, which had been on a venison recovery operation on the West Coast. Searchers on the subsequent search and rescue helicopter found that the pilot had been fatally injured in the accident. A TAIC investigation into the accident is currently underway.

The crashed helicopter at the site.

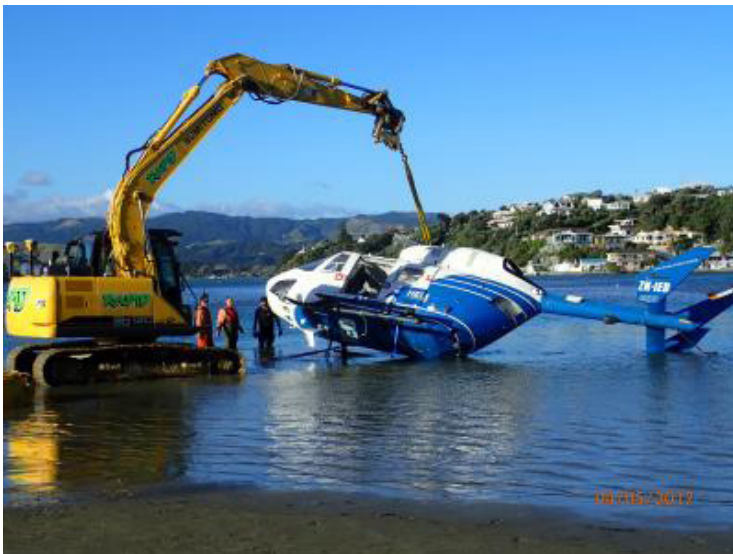
The helicopter was on an external load operation relocating power poles from the northern side of the Pauhatanui inlet to the southern side. The pilot reported that during the cruise at approximately 300ft the aircraft started an un-commanded yaw, at which point he released the sling load and entered into an auto rotation. The aircraft impacted the water and the pilot managed to exit unharmed. A TAIC investigation into the accident is currently underway.

The helicopter being lifted out of the harbour.

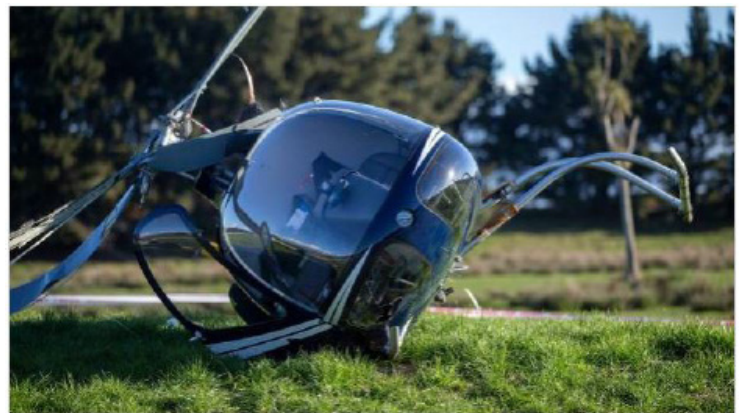
The helicopter was on a dual training flight when there was a loss of control. While on approach to a hover, the helicopter developed a rapid left yaw as translational lift was lost. The pilot was unable to arrest the yaw rate and regain control of the helicopter, and the aircraft struck the ground in an adjacent paddock. One pilot received a serious injury and the other recieved a minor injury.

The accident scene.
