NEW ZEALAND HELICOPTER

SAFETY UPDATE

DECEMBER 2019

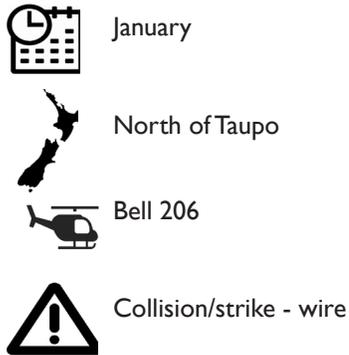
The helicopter hit power lines and crashed while spraying. During the last load of the job and while searching for broom to spray, the aircraft contacted high voltage power lines. The aircraft rotors cut through the power lines, rendering the helicopter uncontrollable, and it subsequently impacted the ground. The pilot indicated that although he was aware of the power lines, he lost situational awareness while focused on the search for pockets of broom.

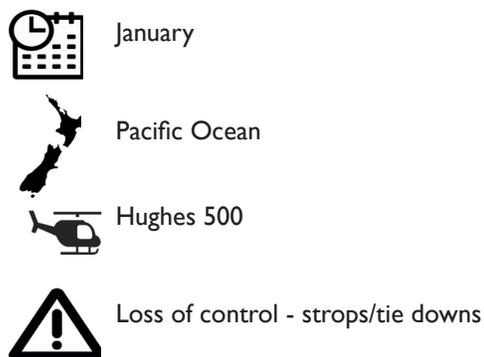
It was reported that the New Zealand - registered helicopter attempted to take off while still strapped to the deck of a boat by one line. The aircraft was unable to climb and rolled back onto the deck.

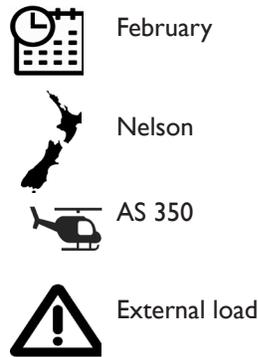
The helicopter was engaged in fire-fighting duties when the pilot noticed a sudden yaw to the left followed by another to the right. This was followed by a sudden pitch up. The pilot immediately jettisoned the monsoon bucket. The pilot found he had little directional control but was able to control the rate of descent down to the ground. The cause of the loss of control was the monsoon bucket making contact with the tail rotor. The operator's investigation identified that the most probable cause was that the top ring in the bucket partially collapsed. An extract from the findings section of the report states: ***It is probable that the top ring in the bucket partially collapsed when the PIC was on his last dip fill essentially turning the bucket into a sack without the rigid top ring in place. Once the pilot released the water from the bucket and gained forward speed while travelling back down the valley the bucket would have experienced significant aerodynamic drag which moved it upward into the tail boom and tail rotor.***

The bucket was a Cloudburst CB1000MF. From the report: ***This investigation has highlighted a possible risk factor when operating the older style Cloudburst CB1000MF bucket with a collapsible top ring that is secured by Velcro. Partial collapse of the ring or if the ring comes away from the Velcro could cause an empty bucket to 'fly' erratically in flight and move dangerously close to the tail.***

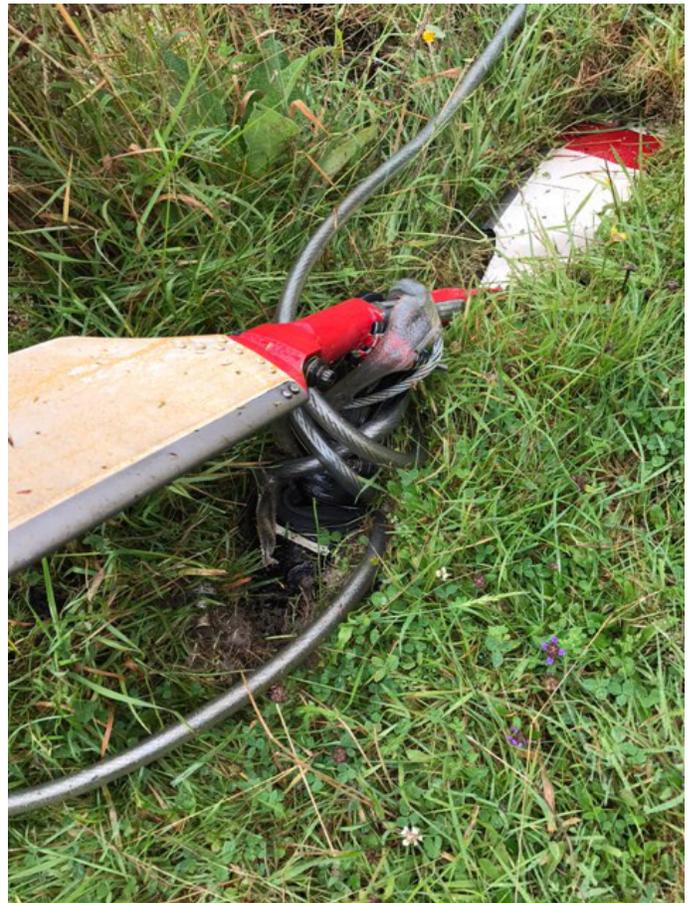
A MD 369E was conducting external load operations moving beehives in the Raetihi area. For this operation, two company helicopters had been engaged, with both pilots electing to use a bee-wing, attached to the belly hook of the aircraft with a short 10 metre cable, to lift the pallets of beehives. At approximately 0920 hours NZDT, the aircraft was on a return flight from the drop off location when the cable, weighted only with the bee-wing, came into contact with the tail rotor. This resulted in the cable wrapping around the tail rotor hub and gearbox, causing the tail rotor assembly and cable with the bee-wing attached, to depart from the aircraft. As a result, the aircraft yawed to the right and the pilot was unable to maintain directional control. After several rotations, the aircraft struck the side of a ridge, rolled approximately 35 metres down the slope and came

The safety investigation was unable to determine conclusively why the cable contacted the tail rotor. It is most likely that the short strop, low mass configuration increased the risk of contact with the tail, particularly when combined with an airspeed at which the load may become unstable.

Image of the cable wrapped around the tail rotor.

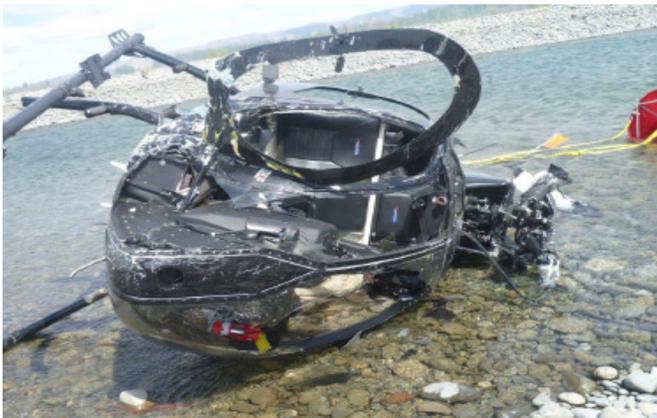
While refilling the monsoon bucket in the Wairau River one of the four strops attached from the helicopter hook to the bucket got caught around the left rear skid (also fitted with a snow shoe). The pilot descended to release tension and the current carried the bucket down stream pulling the aircraft out of C of G and causing tail rotor strike. The aircraft spun around several times uncontrollably and ended up on its side in shallow water on the river bank. The operator investigated and identified the following lessons from the accident:

Image of the wreckage.

- Fire bucket harnesses should not be connected directly to the hook. Instead they should be attached to a long line of at least 7 metres, meaning the pilot has only one line to focus on instead of four;
- 7mm non-rotating steel wire rope should be used because these do not catch in the wind or flutter; and
- Fire fighting with a monsoon bucket should be included in the annual flight crew competency check, during which pilots must demonstrate their ability to rig the load safely.

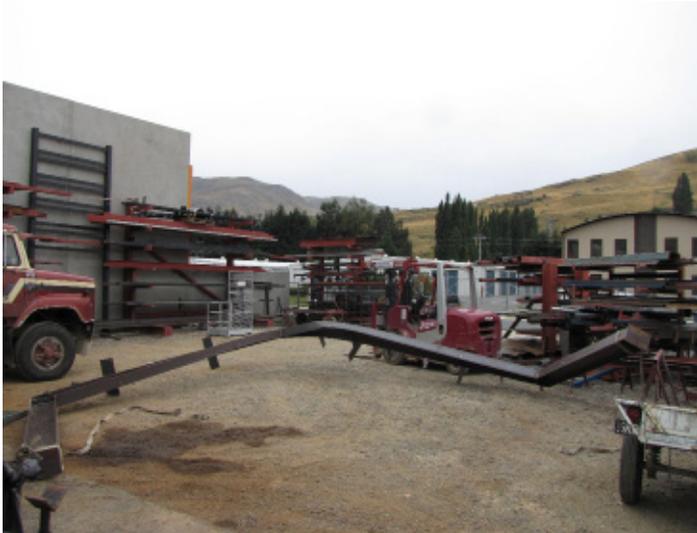
The pilot was conducting external load operations from an engineering company premises on to a building site. The external loads consisted of 780 kg steel portals which the operator was required to lift from the yard at the rear of the engineering premises and then fly to the drop-off site. During the lift of the second portal on the day the nylon ropes used to lift the portal failed, allowing the portal to fall to the ground landing in the rear yard of the premises. Two employees of the engineering company were positioned within the yard holding 'tag' ropes to control the load as it was lifted. Neither person was

injured during the incident however the portal was substantially damaged.

Image of the fallen portal.

The portal was rigged by two employees from the engineering firm using two 680 kg nylon ropes provided by the operator. This load was lifted to a height of approximately 8 metres at which height the helicopter stabilised in the hover (potentially to enable the stability of the load to be assessed by the pilot). At that point one of the ropes failed, transferring the entire 780 kg weight onto the remaining (680 kg rated) rope. The single remaining rope then also failed allowing the portal to fall back into the engineering yard. The cleat had cut through both the padding and the nylon rope.

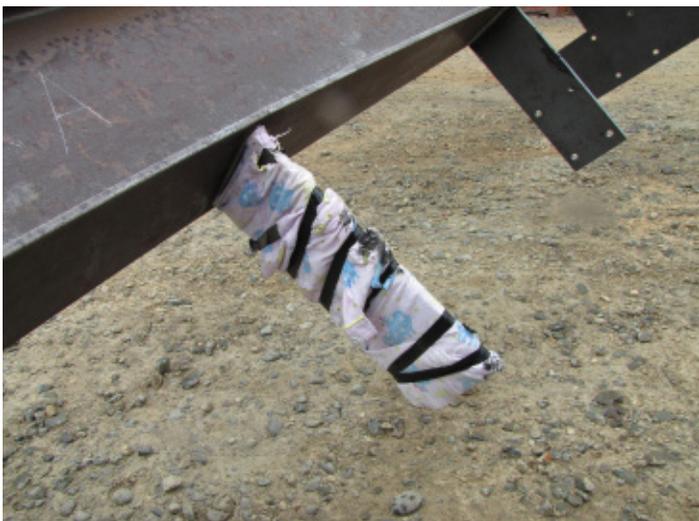
Prior to the job an on-site meeting was held at the incident site between the pilot and the staff. At this meeting the sharp edges of the metal cleats were discussed and a request was made by the pilot for padding to be placed on the cleats that would come in contact with the strops. The engineering staff carried this out by wrapping rags around the cleats, secured by tape.

Image of the padding applied to the portal cleat.
