# NEW ZEALAND HELICOPTER

## SAFETY UPDATE

JULY 2020

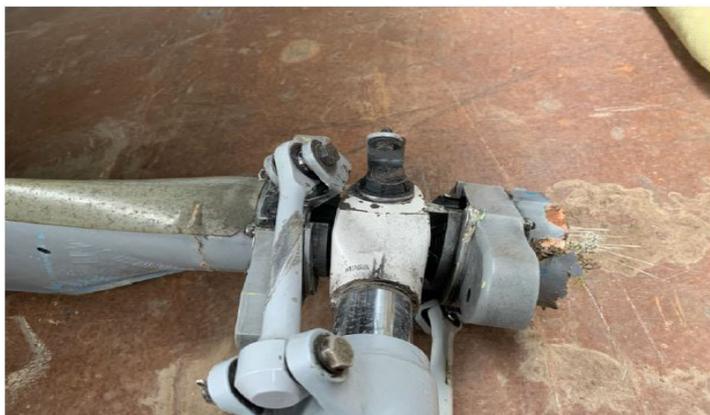
External Load - Tail Rotor Contact

The helicopter was engaged on beehive slinging operations. On takeoff from the staging area, the pilot was not aware that the long line was connected to the helicopter. The long line contacted the tail rotor and the helicopter crashed. The pilot sustained serious injuries and the crewman on board sustained moderate injuries. The investigation report stated:

“A number of factors contributed to the accident, the main root cause identified was that clear verbal communication was not used regarding the connection of the long line.” Image of the TR below.

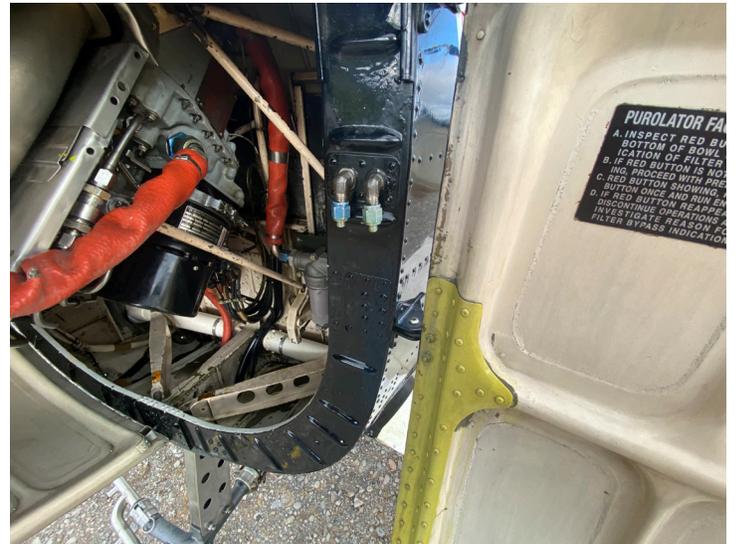
Oil System - Maintenance

Pilot landed to find oil splatters over the cowl doors. The helicopter had flown approximately 3 hours since return to service from a compressor change. On opening of the cowl doors the pilot found two nozzles that were meant to be lock wired not completely closed which allowed the oil to leak. Engineer confirmed this was the cause. Pilot refilled oil and closed nozzles. The investigation report identified several human factors elements relating to maintenance. The report noted: *“Human factors weigh in heavily with this incident. One of the engineers would normally carry out the work, and the senior engineer would check it afterward, this time the senior helped to speed up the turnaround time and they both missed the drain blanks being correctly fastened. There was no apparent oil leaking during the ground run and no leak on post flight check.*

*Normally one engineer would carry out the work, while a senior engineer would check this work. In an attempt to speed up the turnaround time (stress factor) both engineers worked on the aircraft at the same time. Subsequently both who had been working on the aircraft missed the drain blanks being correctly fastened”.*

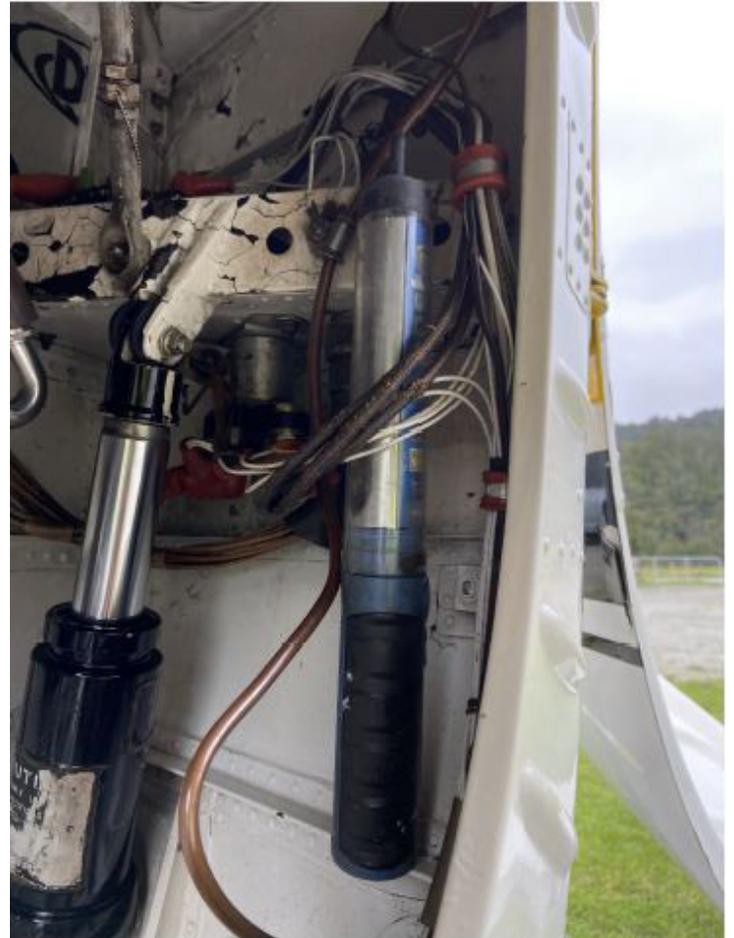
Maintenance

Following a flight after a 300 hour maintenance check, a torch was found behind some wiring in the engine bay, after the engineer called asking the operator to check for the missing torch. The operator approached the maintainer about the incident,

evidently the personal tool check was carried out after the helicopter left the maintenance hangar. The operator also undertook to remind pilots via a memo of the importance of carrying out thorough pre-flight inspections following maintenance. Image below.
