# New Zealand Helicopter Sector Safety Update

April 2021

# New Zealand Helicopter Sector Safety Update – April 2021

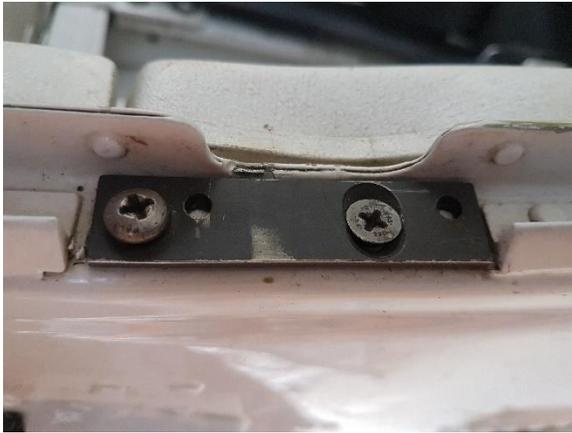
**Hughes 500**

**Door striker fault**

Co-pilot door found to be not latching on all strikers. Lower striker found to have loop missing, possibly knocked off by passenger disembarking. Lower striker replaced with new striker. Image below:

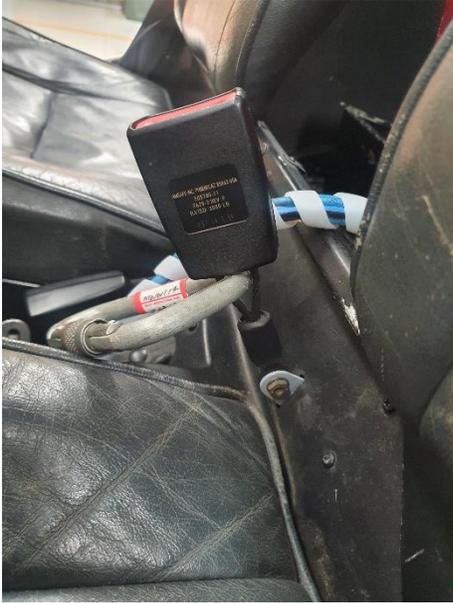
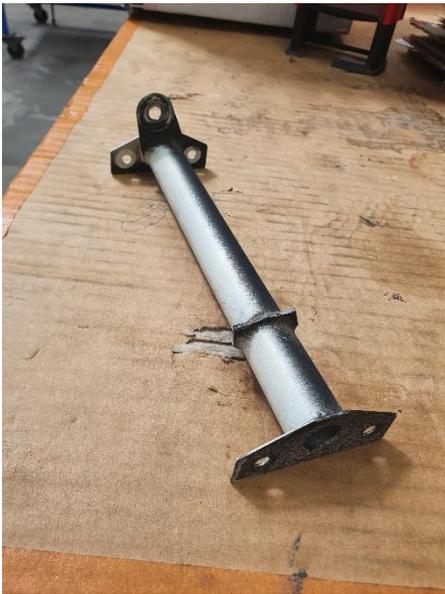
**R44**

**Seat harness**

Shooters Improvised harness failure. The shooter had his harness hooked to 2 carabiners attached to the bottom seatbelt and was undoing them to get out of the helicopter when the seat belt came away from the metal attached to the aircraft.

The carabiners were hooked through the wire of the locking mechanism of the seat belt, the connecting side of the seatbelt was hooked up out of the way. The co-pilot buckle was used outside of its intended purpose. Defective item replaced. The shooter's seatbelt (front left) broke away from the aircraft due to apparent fatigue caused by repetitive use in a manner that wasn't fit for purpose.

The initial response was to rig up a harness restraint utilising the rear seatbelts. This was identified as not being an acceptable measure because of airworthiness/design issues with the usage of seatbelts outside of their intended scope.

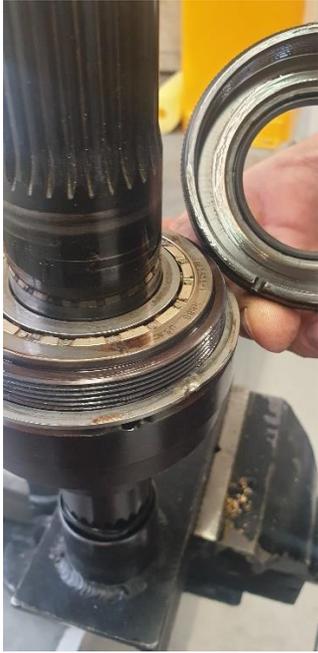
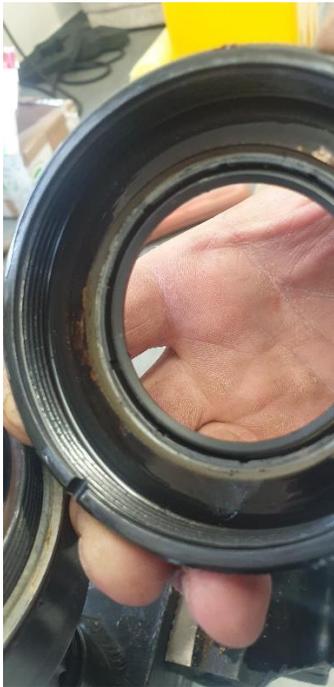
**Hughes 500N**

**Clutch assembly**

During routine maintenance, it was noted the Overrunning Clutch oil level was zero. The clutch assembly purchased through Maintenance Company 3rd August 2020, which was supplied via MD Helicopters

from O/H supplied on 8130 # W18-030. Found the upper housing O' Ring missing from clutch assembly. Missing part caused the clutch to dump its oil, leaving it running dry for 100hrs. Clutch removed and sent to Maintenance Company for warranty claim. Images below:

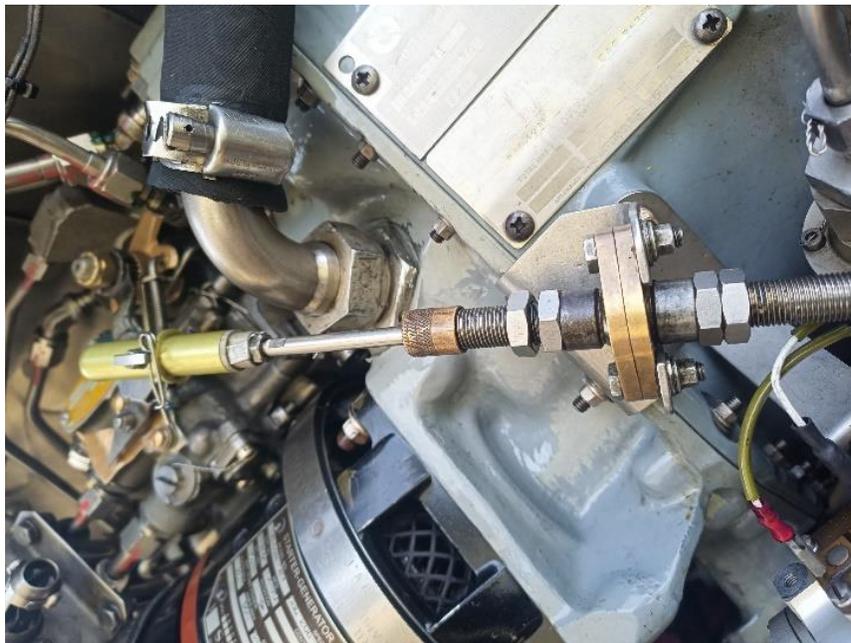
**AS 355**

**Loose cable jam nuts**

During pre flight inspection the pilot noted #2 FCU input cable jam nuts were loose – this was a maintenance and duplicate inspection failure. A safety card was raised, Maintenance provider notified and both sides checked. Meeting with maintenance provider to be carried out. Image below:

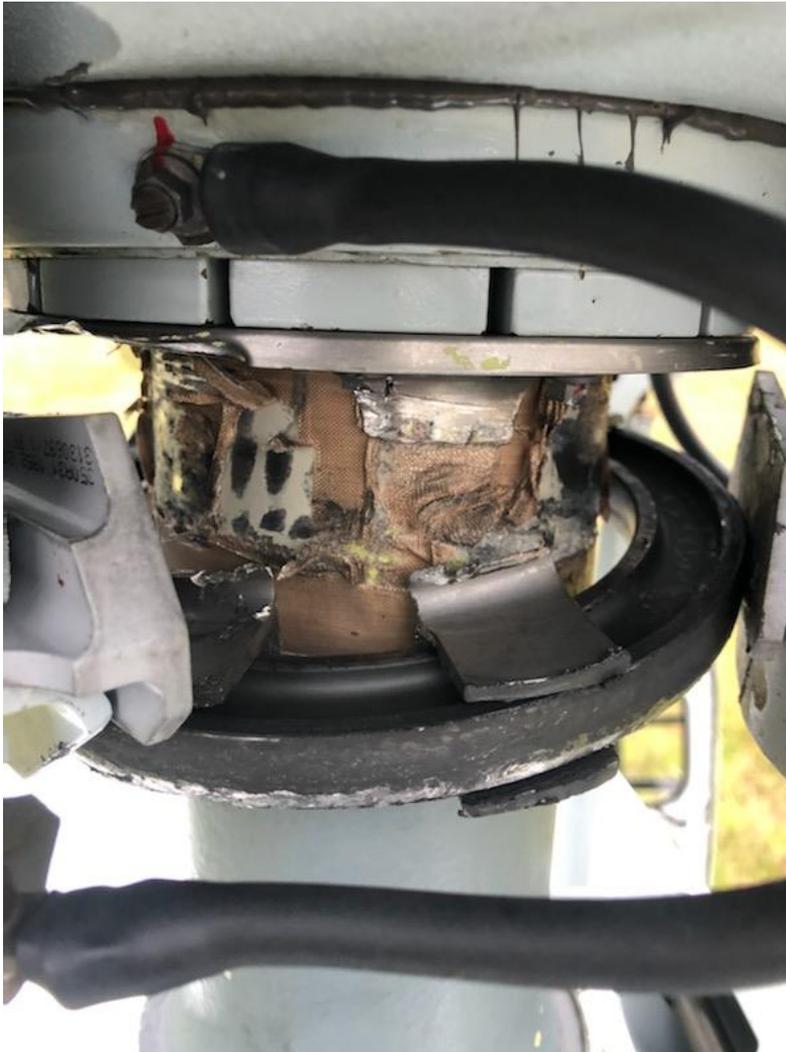
**As 350**

**Droop stop supports**

Upon shut down the pilot detected a metallic noise coming from the rotor system. On inspection found two of the M/R droop stop supports broken. The damage was likely caused by continued operation from a sloped landing site causing blade droop stop contact with M/R blade droop stops. Defective parts removed, area inspected IAW the manufactures recommendations and new parts installed. Image below:
