NZ Agricultural Aviation Activity and Safety Update September 2016

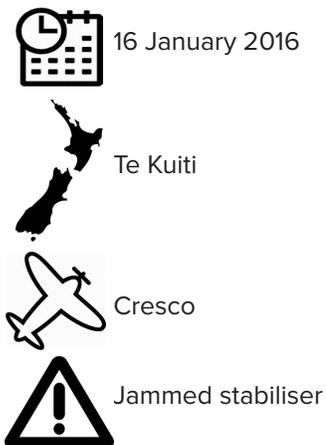
The Cresco's elevator jammed solid moments after the pilot landed on a newly metaled airstrip. On inspection an aluminium tab was found stuck in the plastic protector on the leading edge of the stabiliser. The strip had been metalled and rolled but had loosened-up over the course of the job, causing the tab to become jammed in the

stabiliser and also causing a few minor 'cuts' on the underside of the stabiliser.

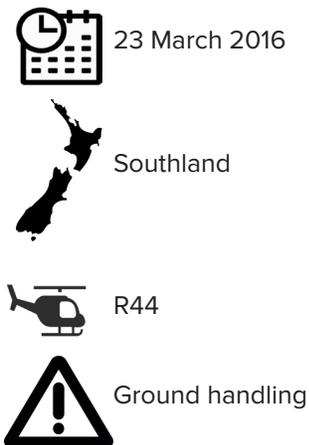
The incident occurred during a helicopter spray operation. On lift off and crossing a sheep fence a thumping sound and jerking movement was noticed by the pilot which went away once clear of the fence. A precautionary landing was carried out. Inspection revealed that the suction hose was still attached to the skid pump.

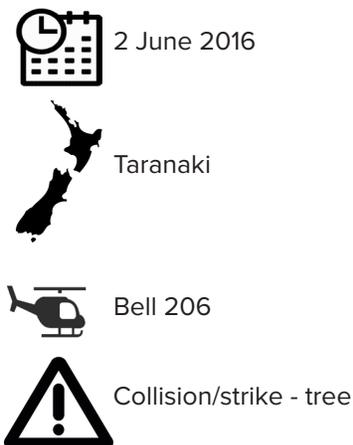
During agricultural spraying operations, the spray boom clipped a spar (dead standing tree) in the forestry block. A precautionary landing was carried out. The pilot reported that he had carried out a full reconnaissance flight of the spraying block before the job and was aware of the lone spar. It was early in the morning and the sun was coming up into the flight path. In addition they reported they were having trouble with a partially

fogged window and the GPS unit was causing some distraction. While there was no damage caused to the spray boom or the aircraft, the operator undertook to distribute a notice and had a briefing with staff about the hazards of early morning spraying and distractions in the cockpit.

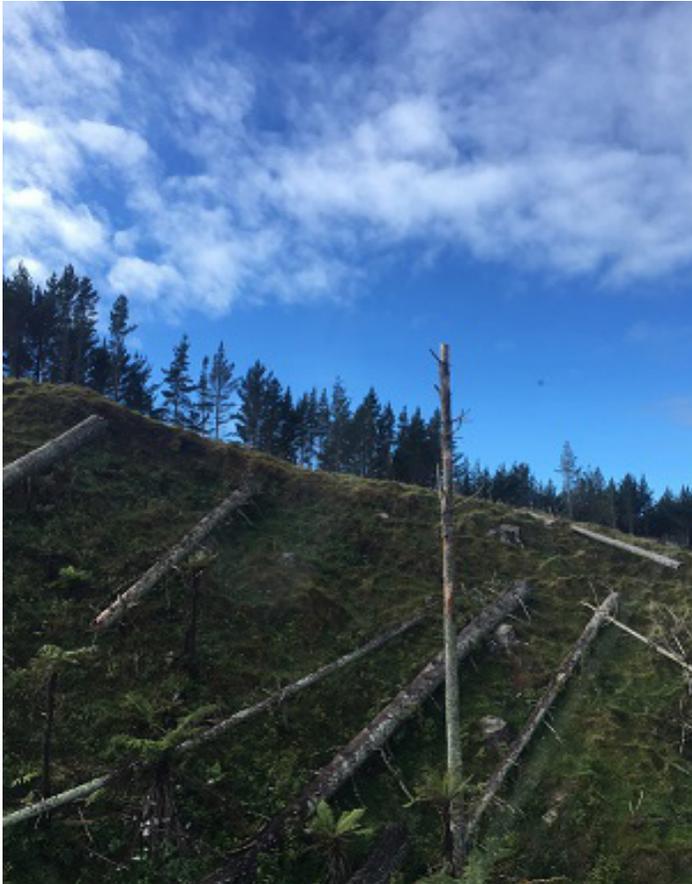
Image: operator's image of the dead tree (spar)

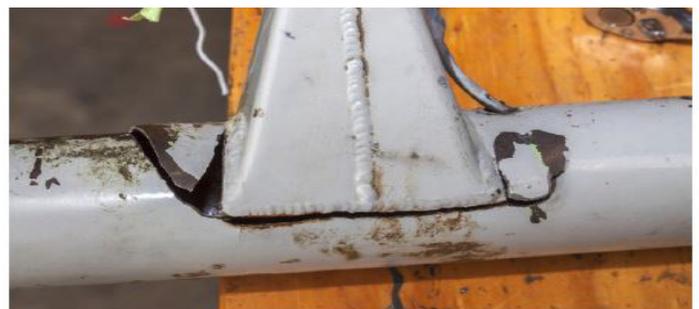
During agricultural operations the pilot became aware of limited left-hand aileron control, and landed the aircraft. An inspection revealed that the pilot's right-hand side elevator torque tube was broken and the section bent sufficiently to interfere with aileron operation - indicated by witness marks on the lower aileron control quadrant. The cause was identified as metal fatigue (17,700 airframe hours on the aircraft), which was likely exacerbated by cockpit occupants standing on the torque tube to enter/exit the cockpit. This defect report resulted in an Emergency Airworthiness Directive for Crescos and Fletchers - available [here](#).

Elevator Torque Tube P/N 242646 (Item 14) – Fractured area.

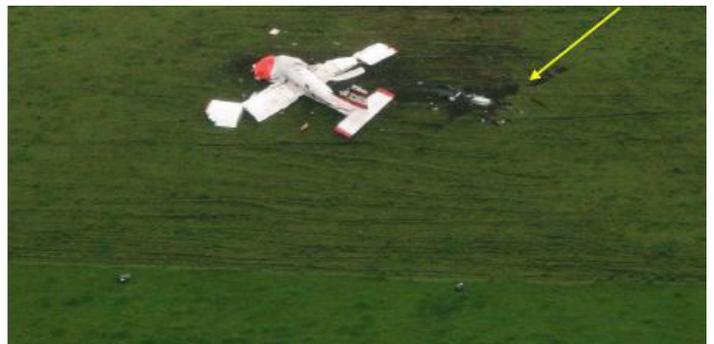
Figure 7: the accident scene.

The aircraft was engaged in topdressing operations from a farm property near Tarata, approximately 14 nautical miles south-east of New Plymouth Aerodrome. The aircraft loader driver became concerned when the aircraft had not returned to the airstrip, and after climbing a small hill, saw that the aircraft had suffered an accident approximately 600 metres from the departure end of the airstrip. The pilot was killed. The investigation determined that the aircraft crashed after takeoff when it failed to achieve the required climb performance and struck a fence which severely damaged the elevator control cable and rendered the aircraft uncontrollable. There was a trail of lime leading up to the fence and the jettison lever was found in the full jettison position. Some 150kg of lime remained in the hopper.

It was determined that the aircraft was likely overweight for the prevailing conditions, which lead to the collision with the fence and subsequent damage to the elevator control cable. Approximately 20 minutes before the accident time (11:55am) there had been a change in wind direction which may have introduced a tailwind component and possibly turbulence during takeoff. The weather was forecast to deteriorate further with the approach of a low pressure system later in the day. The pilot was also due to start extended leave on completion of the job. Both of these elements may have introduced some pressure to spread the remaining lime and complete the job. Lastly, the windsock had not
