NEW ZEALAND HELICOPTER

SAFETY UPDATE

DECEMBER 2019

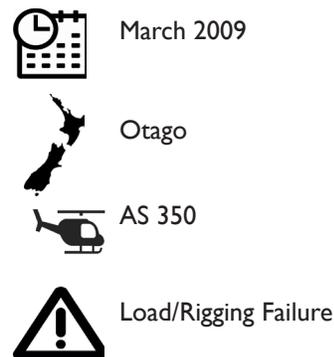
The pilot was conducting external load operations from an engineering company premises on to a building site. The external loads consisted of 780 kg steel portals which the operator was required to lift from the yard at the rear of the engineering premises and then fly to the drop-off site. During the lift of the second portal on the day the nylon ropes used to lift the portal failed, allowing the portal to fall to the ground landing in the rear yard of the premises. Two employees of the engineering company were positioned within the yard holding 'tag' ropes to control the load as it was lifted. Neither person was

injured during the incident however the portal was substantially damaged.
