NEW ZEALAND AGRICULTURAL AVIATION

SAFETY UPDATE

DECEMBER 2019

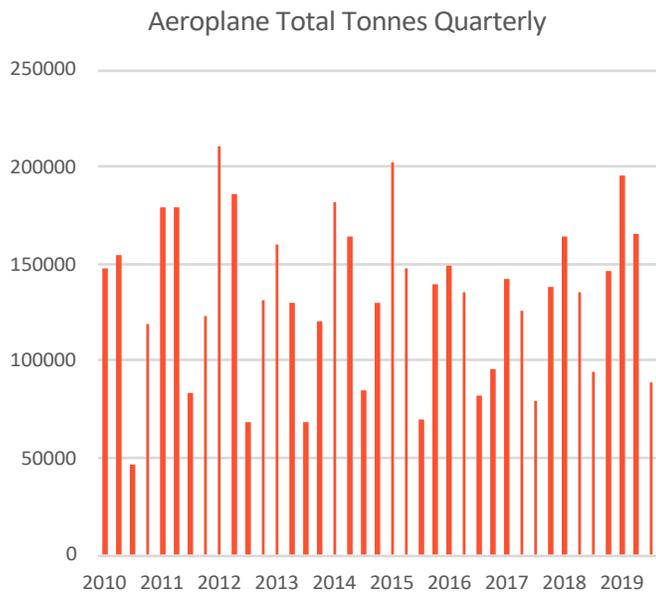
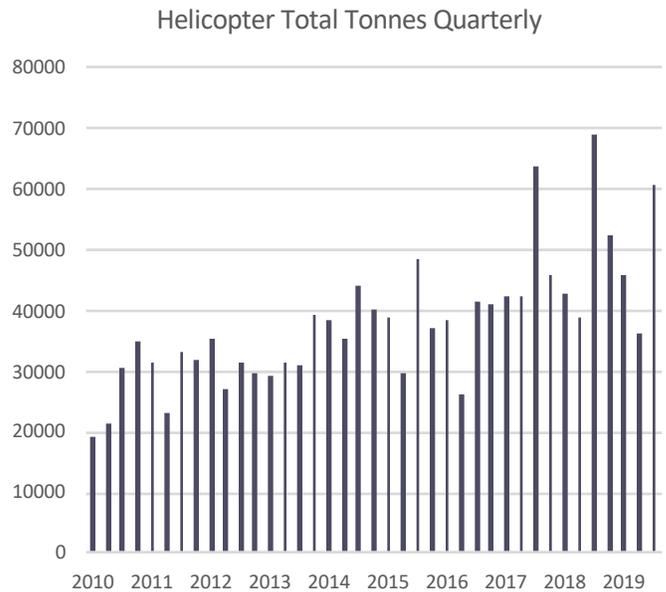
The agricultural product statistics to date indicate that overall sector activity has been higher than in 2018. A total 592,736 tonnes have been reported, 48,000 more than for the first three quarters of 2018. The increase has been driven exclusively by fixed wing agricultural operations; helicopter operators have reported lower tonnages than last year, particularly in the third quarter.

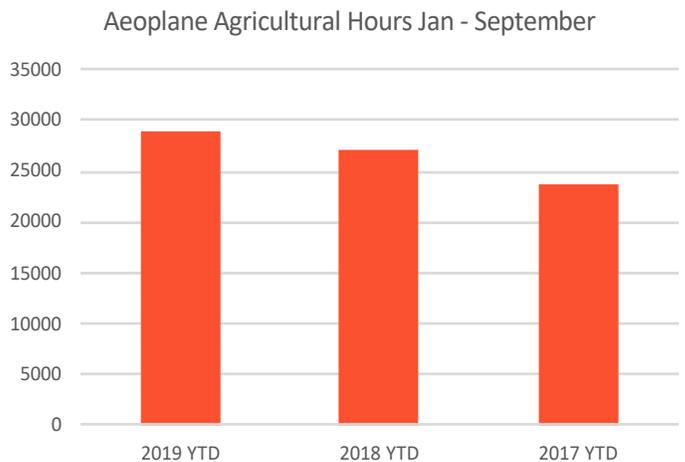
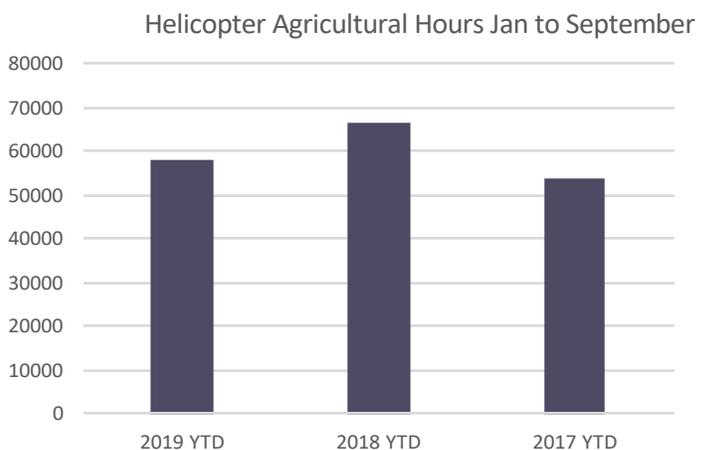
The increased fixed wing activity is also reflected in the reported hours - 1,950 more hours were flown for the 2019 year to September than the same period in 2018.

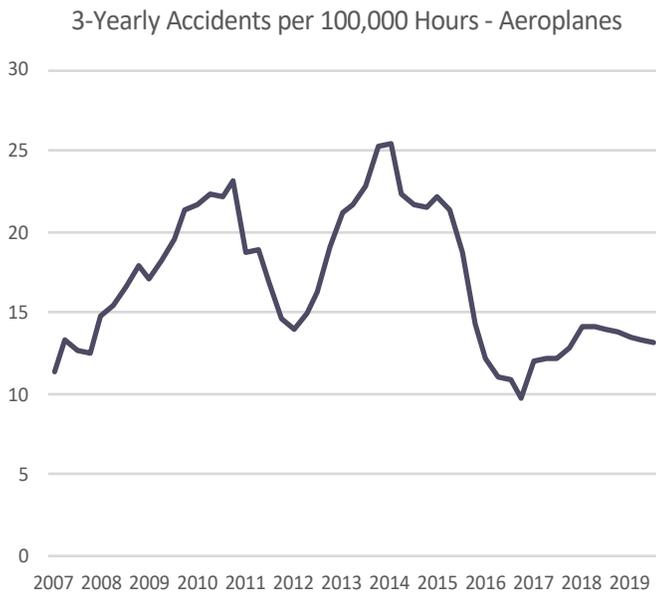
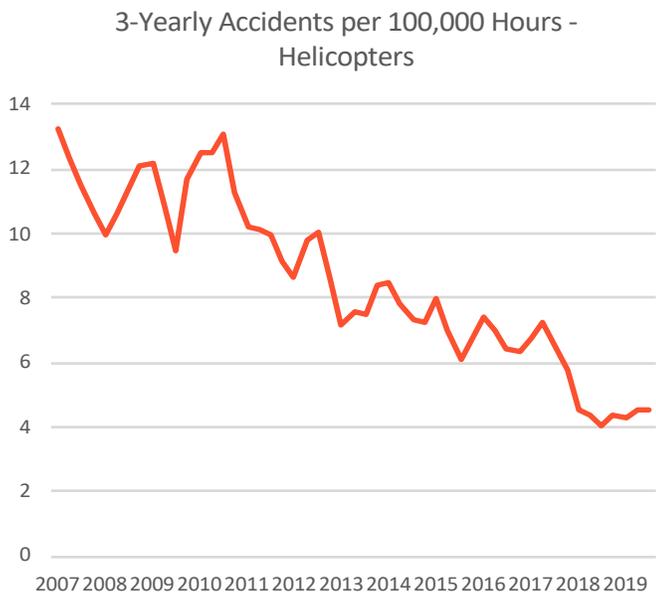
There have been 5 accidents on agricultural operations in the year to date; for the same period in 2018 there were also 4 accidents. The accident rate trend for both fixed wing and helicopter agricultural operations has recently been increasing. The charts below show the rolling average 3-yearly accidents per 100,000 hours. The current rate for fixed wing operations is **13.22** while for helicopter operations it is **4.49**.
